**Flood Control Project Maintenance
Levee Inspections**
LMA District Cover Sheet
Spring 2018 Levee Inspection Results

Reclamation District No. 2063 Crows Landing

Waterway			Bank	Unit Miles
Unit No. 01 San Joaquin River			Right	10.44
	Spring (March - May)	Summer (June - August)	(September - November) Fall	Winter (December - February)
Unit Maintenance Rating (Fall Only)				
Date of Inspection	3/27/2018 - 3/27/2018			
DWR Inspector	Richard Willoughby			
Accompanied By	Joe Sallaberry RD2063

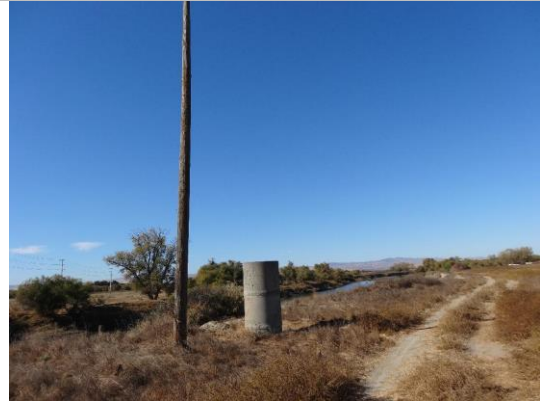
Photo 1 of 3 : UCIP_SP_2018_50216_43166.jpg

FS_ID:50216
DS_ID:22075
EP_NO: N/A
Repair Type: Non-Urgent
Crossing Status: Indicator Found
UCIP Comments: 08/23/2016: Could not locate pipe during inspection, though it was very prominently visible on the WS bank and LS ditch as per 2013 photos. I confirmed with RD2063 president Joe Sallaberry that the pipe was filled with concrete through the levee but removed at the LS ditch. Could not locate pipe's ends during inspection. No permit exists for this work. Crossing has been downgraded from Urgent to Non-Urgent since we lack documentation verifying proper abandonment.

11/05/2013:- Pipe has visible holes throughout both LS and WS along with pipe deformation. - looks abandoned. Needs proper abandonment.- alfalfa valve on concrete pipe riser on waterside toe.- no slide gate found on waterside. No pump and pile structure found in river.

WS view: abandoned concrete standpipe and abandoned power pole.

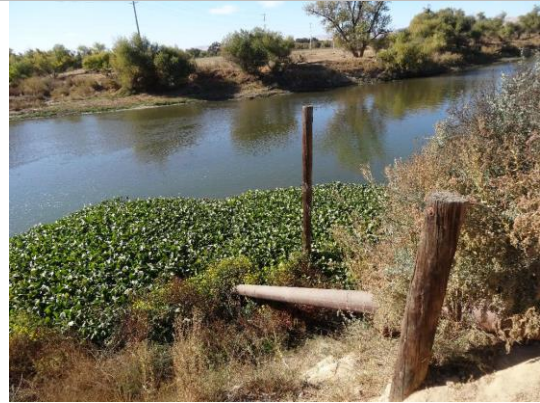
Photo 2 of 3 : UCIP_SP_2018_50216_43161.jpg

Comment Code						
Inspector Comment						
FS_ID:50216 DS_ID:22075 EP_NO: N/A Repair Type: Non-Urgent Crossing Status: Indicator Found UCIP Comments: 08/23/2016: Could not locate pipe during inspection, though it was very prominently visible on the WS bank and LS ditch as per 2013 photos. I confirmed with RD2063 president Joe Sallaberry that the pipe was filled with concrete through the levee but removed at the LS ditch. Could not locate pipe's ends during inspection. No permit exists for this work. Crossing has been downgraded from Urgent to Non-Urgent since we lack documentation verifying proper abandonment. 11/05/2013:- Pipe has visible holes throughout both LS and WS along with pipe deformation. - looks abandoned. Needs proper abandonment.- alfalfa valve on concrete pipe riser on waterside toe.- no slide gate found on waterside. No pump and pile structure found in river. FIELD_STRUCT_DESC: *ABANDONED* 24-inch corrugated metal irrigation discharge pipe through the levee, 10 feet below the crown, not found during 2016 inspection. Slide gate in a corrugated metal pipe (CMP) riser on the waterside (WS) slope, not found during 2016 inspection. Pipe supported on two timber pile bents across a drainage ditch on the landside (LS), only pile remnants found during 2016 inspection. Pump on a pile structure in the river, not found during 2016 inspection. Two concrete standpipes on the WS berm, one of which was found during the 2016 inspection. Installed by USACE in 1961. [Additional Reference(s): DWR Levee Log, 1992. USACE San Joaquin O&M Manual 6, September 1961, (HLM 1.29)]. FS Date: 8/23/2016

WS view: steel pipe immersed into the river. No pump found.

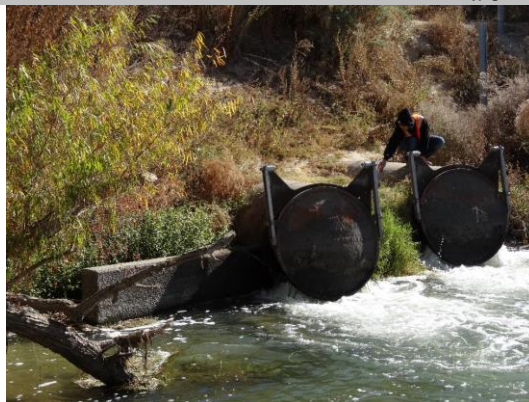
Photo 2 of 3 : UCIP_SP_2018_50218_43203.jpg

Comment Code					
Inspector Comment					
FS_ID:50218					
DS_ID:22076					
EP_NO: N/A					
Repair Type: No Action Needed					
Crossing Status: Found					
UCIP Comments: 08/23/2016: WS flapgates were held open by a piece of wood. Pipes may be used temporarily for irrigation. (K. Fazel - UCIP)11/05/2013: working during the inspection. (P. Amatya - DWR)					
FIELD_STRUCT_DESC: [Lateral Drain No. 5] 1 of 2: 48-inch corrugated metal gravity drainage pipe through the levee, 25.5 feet below the crown. Slide gate in a corrugated metal pipe (CMP) riser on the waterside (WS) slope. Flap gate on the WS end. 70-foot-long cobble spillway to river. Installed by USACE in 1961. [Additional Reference(s): DWR Levee Log, 1992. USACE San Joaquin O&M Manual 6, September 1961, (HLM 1.35)].					
FS Date: 11/5/2013

WS view: two outfall CMP pipes with flap gates on concrete headwall.

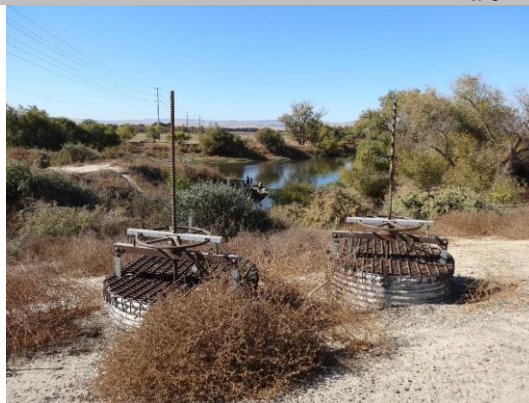
Photo 3 of 3 : UCIP_SP_2018_50218_43202.jpg

Comment Code						
Inspector Comment						
FS_ID:50218						
DS_ID:22076						
EP_NO: N/A						
Repair Type: No Action Needed						
Crossing Status: Found						
UCIP Comments: 08/23/2016: WS flapgates were held open by a piece of wood. Pipes may be used temporarily for irrigation. (K. Fazel - UCIP)11/05/2013: working during the inspection. (P. Amatya - DWR)						
FIELD_STRUCT_DESC: [Lateral Drain No. 5] 1 of 2: 48-inch corrugated metal gravity drainage pipe through the levee, 25.5 feet below the crown. Slide gate in a corrugated metal pipe (CMP) riser on the waterside (WS) slope. Flap gate on the WS end. 70-foot-long cobble spillway to river. Installed by USACE in 1961. [Additional Reference(s): DWR Levee Log, 1992. USACE San Joaquin O&M Manual 6, September 1961, (HLM 1.35)].						
FS Date: 11/5/2013

WS view: two slide gates in CMP risers on levee slope.

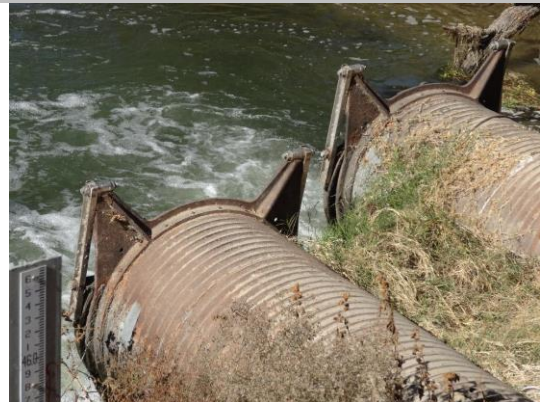
Photo 2 of 3 : UCIP_SP_2018_50217_43216.jpg

Comment Code						
Inspector Comment						
FS_ID:50217 DS_ID:22119 EP_NO: N/A Repair Type: No Action Needed Crossing Status: Found UCIP Comments: 08/23/2016: WS flapgates were held open by a piece of wood. Pipes may be used temporarily for irrigation. (K. Fazel - UCIP)11/05/2013: working during field inspection. (P. Amatya - DWR) FIELD_STRUCT_DESC: [Lateral Drain No. 5] 2 of 2: 48-inch corrugated metal gravity drainage pipe through the levee, 25.5 feet below the crown. Slide gate in a corrugated metal pipe (CMP) riser on the waterside (WS) slope. Flap gate on the WS end. 70-foot-long cobble spillway to river. Installed by USACE in 1961. [Additional Reference(s): DWR Levee Log, 1992. USACE San Joaquin O&M Manual 6, September 1961, (HLM 1.35)]. FS Date: 11/5/2013

WS view: two CMP outfall pipes with flap gates on levee slope.

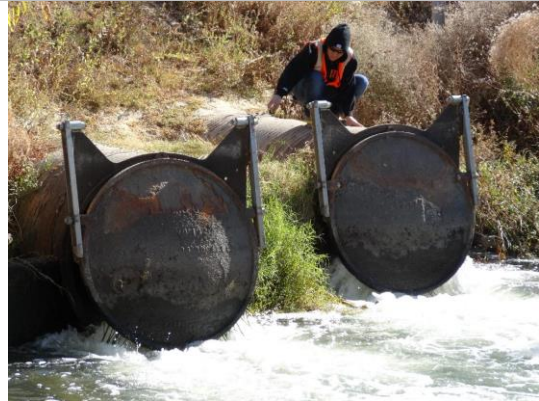
Photo 3 of 3 : UCIP_SP_2018_50217_43215.jpg

Comment Code						
Inspector Comment						
FS_ID:50217 DS_ID:22119 EP_NO: N/A Repair Type: No Action Needed Crossing Status: Found UCIP Comments: 08/23/2016: WS flapgates were held open by a piece of wood. Pipes may be used temporarily for irrigation. (K. Fazel - UCIP)11/05/2013: working during field inspection. (P. Amatya - DWR) FIELD_STRUCT_DESC: [Lateral Drain No. 5] 2 of 2: 48-inch corrugated metal gravity drainage pipe through the levee, 25.5 feet below the crown. Slide gate in a corrugated metal pipe (CMP) riser on the waterside (WS) slope. Flap gate on the WS end. 70-foot-long cobble spillway to river. Installed by USACE in 1961. [Additional Reference(s): DWR Levee Log, 1992. USACE San Joaquin O&M Manual 6, September 1961, (HLM 1.35)]. FS Date: 11/5/2013

WS view: front view of two CMP outfall pipes with flap gates on levee slope.

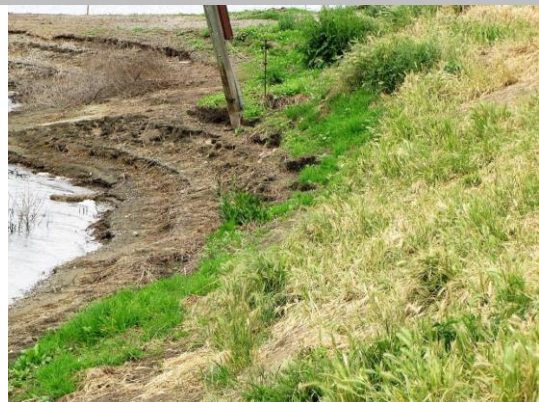
Photo 1 of 4 : SP_2018_RD2063_112_59_20180307_00011.jpg

LM Start	1.83	Rating **	A/W	Issue No.	59
LM End	1.93	Issue Type +	Ma	Location *	WS
Category	Earthen Levee			GPS Latitude/Longitude	
				Start	End
Item	Erosion / Bank Caving			37.457653 °	37.456258 °
				-121.033728 °	-121.033645 °
DWR ID	DWR_RD2063_01_s_2017_59				
Comment Code					
E1 : Note and monitor erosion site.					
Inspector Comment					
Minor erosion at waterward slope was repaired.

Looking downstream at minor erosion on waterward slope.

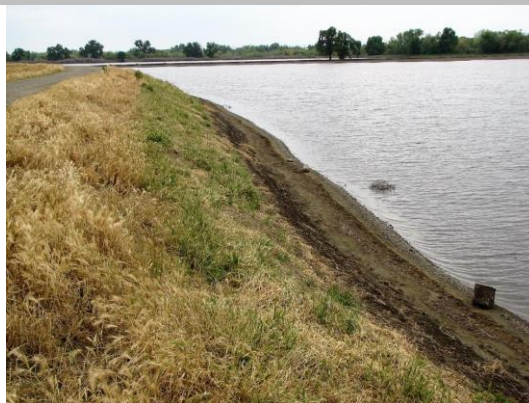
Photo 2 of 4 : SP_2018_RD2063_112_59_20180307_00012.jpg

LM Start	1.83	Rating **	A/W	Issue No.	59 (cont)	
LM End	1.93	Issue Type +	Ma	Location *	WS	
Category	Earthen Levee			GPS Latitude/Longitude		
				Start		End
Item	Erosion / Bank Caving			37.457653 °	37.456258 °	
				-121.033728 °	-121.033645 °	
DWR ID	DWR_RD2063_01_s_2017_59					
Comment Code						
E1 : Note and monitor erosion site.						
Inspector Comment						
Minor erosion at waterward slope was repaired.

Looking upstream at minor erosion on waterward slope.

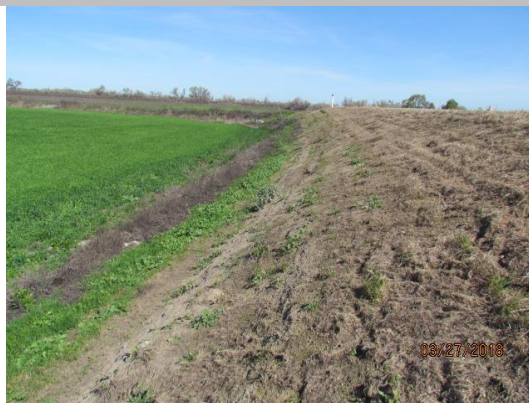
Photo 3 of 4 : SP_2018_RD2063_112_59_20180328_00113.jpg

Looking downstream at repaired site. (Spring 2018)

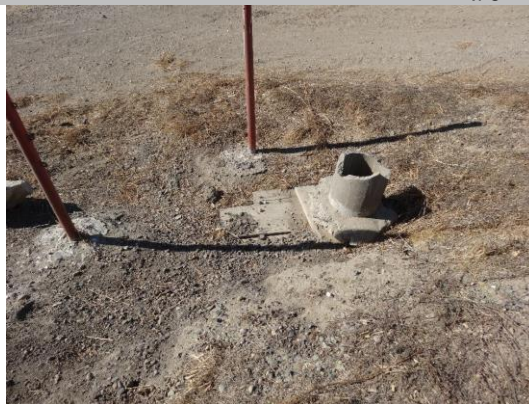
Photo 2 of 3 : UCIP_SP_2018_24404_43344.jpg

Comment Code					
Inspector Comment					
FS_ID:24404 DS_ID:22078 EP_NO: N/A Repair Type: Non-Urgent Crossing Status: Found UCIP Comments: Concrete distribution box with alfalfa valve not found at the waterward toe.Two steel standpipes and dismantled concrete standpipe on waterside levee toe.Concrete distribution box 50 ft off the levee center. FIELD_STRUCT_DESC: 30-inch corrugated metal irrigation discharge pipe through the levee, 16.5 feet below the crown. Slide gate in a concrete distribution box, 50 feet off the levee. Underground irrigation system. Installed by USACE in 1961. [Additional Reference(s): DWR Levee Log, 1992. USACE San Joaquin O&M Manual 6, September 1961, (HLM 2.11)]. FS Date: 11/5/2013

WS view: a dismantled concrete pipe on levee toe.

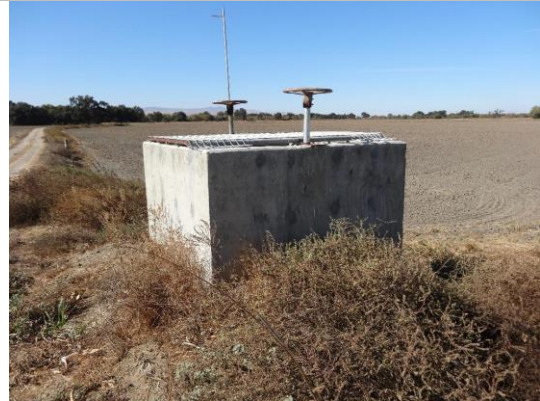
Photo 3 of 3 : UCIP_SP_2018_24404_43343.jpg

Comment Code						
Inspector Comment						
FS_ID:24404 DS_ID:22078 EP_NO: N/A Repair Type: Non-Urgent Crossing Status: Found UCIP Comments: Concrete distribution box with alfalfa valve not found at the waterward toe.Two steel standpipes and dismantled concrete standpipe on waterside levee toe.Concrete distribution box 50 ft off the levee center. FIELD_STRUCT_DESC: 30-inch corrugated metal irrigation discharge pipe through the levee, 16.5 feet below the crown. Slide gate in a concrete distribution box, 50 feet off the levee. Underground irrigation system. Installed by USACE in 1961. [Additional Reference(s): DWR Levee Log, 1992. USACE San Joaquin O&M Manual 6, September 1961, (HLM 2.11)]. FS Date: 11/5/2013

WS view: concrete distribution box with slide gate off the levee toe.

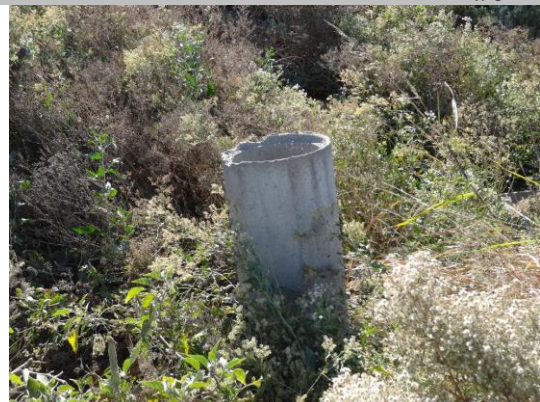
Photo 1 of 3 : UCIP_SP_2018_51823_43348.jpg

Comment Code					
Inspector Comment					
FS_ID:51823					
DS_ID:22081					
EP_NO: N/A					
Repair Type: No Action Needed					
Crossing Status: Found					
UCIP Comments: - concrete standpipe on waterside toe.- concrete distribution box on landside.- an alfalfa valve on waterside toe.					
FIELD_STRUCT_DESC: 30-inch corrugated metal gravity drainage pipe through the levee, 12 feet below the crown. Flap gate on the waterside (WS) end. Slide gate in a concrete distribution box on the landside (LS) end. Concrete U-shaped headwall on the WS end. [Additional Reference(s): DWR Levee Log, 1992. USACE San Joaquin O&M Manual 6, September 1961, (HLM 2.29)].					
FS Date: 11/5/2013

WS view: concrete standpipe on levee toe.

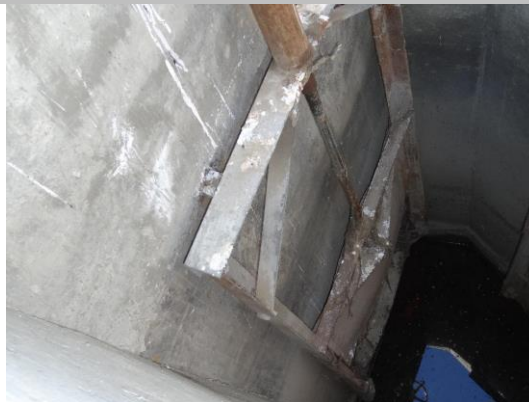
Photo 3 of 3 : UCIP_SP_2018_51823_43346.jpg

Comment Code						
Inspector Comment						
FS_ID:51823						
DS_ID:22081						
EP_NO: N/A						
Repair Type: No Action Needed						
Crossing Status: Found						
UCIP Comments: - concrete standpipe on waterside toe.- concrete distribution box on landside.- an alfalfa valve on waterside toe.						
FIELD_STRUCT_DESC: 30-inch corrugated metal gravity drainage pipe through the levee, 12 feet below the crown. Flap gate on the waterside (WS) end. Slide gate in a concrete distribution box on the landside (LS) end. Concrete U-shaped headwall on the WS end. [Additional Reference(s): DWR Levee Log, 1992. USACE San Joaquin O&M Manual 6, September 1961, (HLM 2.29)].						
FS Date: 11/5/2013

LS view: slide gate in concrete distribution box.

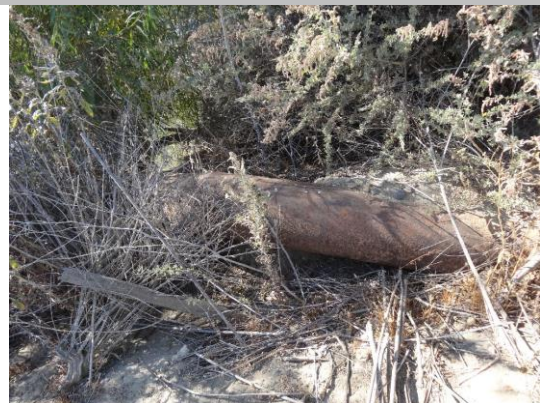
Photo 1 of 3 : UCIP_SP_2018_24427_43439.jpg

Comment Code						
Inspector Comment						
FS_ID:24427 DS_ID:22085 EP_NO: N/A Repair Type: Non-Urgent Crossing Status: Found UCIP Comments: Abandoned steel pipe and service pole on waterside. Pump not found on river bank. CMP riser on waterside slope. Slide gate not found in CMP riser. Steel pipe riser on waterside berm.Damaged PVC standpipe on waterside slope. FIELD_STRUCT_DESC: *ABANDONED* 24-inch corrugated metal irrigation discharge pipe through the levee, 10 feet below the crown. Slide gate in a corrugated metal pipe (CMP) riser on the waterside (WS) slope. 20-inch standpipe 3 feet from the landside (LS) toe. 12-inch pipe across the berm and into a CMP riser on the WS slope. Pump on riverbank. Installed by USACE in 1961. [Additional Reference(s): DWR Levee Log, 1992. USACE San Joaquin O&M Manual 6, September 1961, (HLM 2.46)]. FS Date: 11/5/2013

WS view: abandoned steel pipe on river bank. No pump found on river bank.

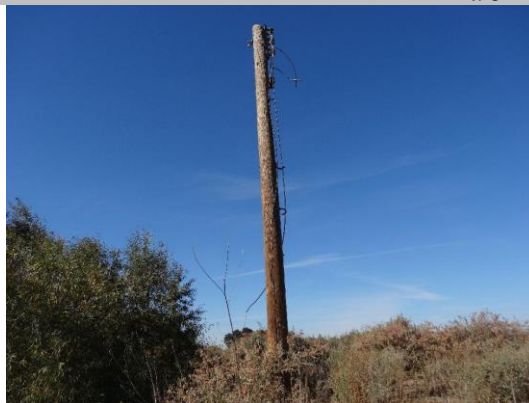
Photo 2 of 3 : UCIP_SP_2018_24427_43438.jpg

Comment Code						
Inspector Comment						
FS_ID:24427 DS_ID:22085 EP_NO: N/A Repair Type: Non-Urgent Crossing Status: Found UCIP Comments: Abandoned steel pipe and service pole on waterside. Pump not found on river bank. CMP riser on waterside slope. Slide gate not found in CMP riser. Steel pipe riser on waterside berm.Damaged PVC standpipe on waterside slope. FIELD_STRUCT_DESC: *ABANDONED* 24-inch corrugated metal irrigation discharge pipe through the levee, 10 feet below the crown. Slide gate in a corrugated metal pipe (CMP) riser on the waterside (WS) slope. 20-inch standpipe 3 feet from the landside (LS) toe. 12-inch pipe across the berm and into a CMP riser on the WS slope. Pump on riverbank. Installed by USACE in 1961. [Additional Reference(s): DWR Levee Log, 1992. USACE San Joaquin O&M Manual 6, September 1961, (HLM 2.46)]. FS Date: 11/5/2013

WS view: abandoned power pole on levee berm.

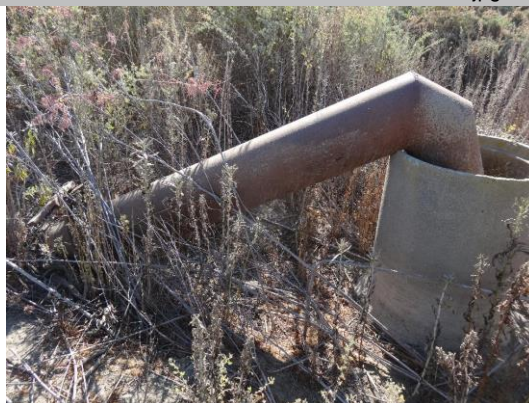
Photo 3 of 3 : UCIP_SP_2018_24427_43437.jpg

WS view: steel pipe and concrete riser on levee berm.

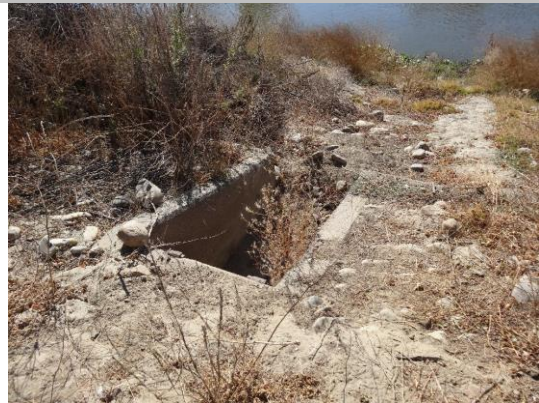
Photo 1 of 3 : UCIP_SP_2018_24435_43484.jpg

LM Start	2.62	Rating **	M	Issue No.	67
LM End	2.62	Issue Type +	Ma	Location *	
Category	Supplemental			GPS Latitude/Longitude	
				Start	End
Item	DWR UCIP LMA Responsibility			37.448233 °	37.448233 °
				-121.026521 °	-121.026521 °
DWR ID					
Comment Code					
Inspector Comment					
FS_ID:24435					
DS_ID:22086					
EP_NO: N/A					
Repair Type: Non-Urgent					
Crossing Status: Found					
UCIP Comments: Both pipe ends 70 ft off the levee center.Clearing and cleaning of inlet/outlet pipe needed.					
FIELD_STRUCT_DESC: 24-inch corrugated metal gravity drainage pipe through the levee, 12 feet below the crown. Flap gate on the waterside (WS) end. Concrete headwall on each end. Installed by USACE in 1961. [Additional Reference(s): DWR Levee Log, 1992. USACE San Joaquin O&M Manual 6, September 1961, (HLM 2.65)].					
FS Date: 11/5/2013

WS view: U shaped headwall outlet structure 70 ft off the levee center.

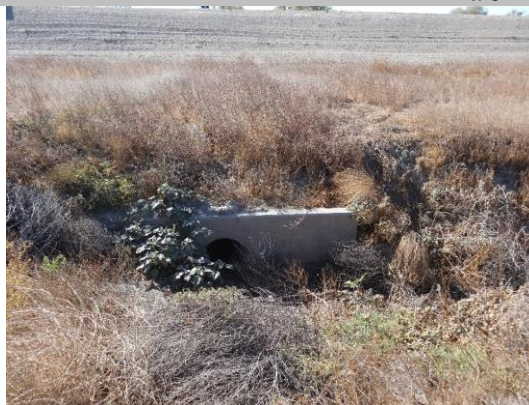
Photo 3 of 3 : UCIP_SP_2018_24435_43482.jpg

LM Start	2.62	Rating **	M	Issue No.	67 (cont)	
LM End	2.62	Issue Type +	Ma	Location *		
Category	Supplemental			GPS Latitude/Longitude		
				Start	End	
Item	DWR UCIP LMA Responsibility			37.448233 °	37.448233 °	
				-121.026521 °	-121.026521 °	
DWR ID						
Comment Code						
Inspector Comment						
FS_ID:24435 DS_ID:22086 EP_NO: N/A Repair Type: Non-Urgent Crossing Status: Found UCIP Comments: Both pipe ends 70 ft off the levee center.Clearing and cleaning of inlet/outlet pipe needed. FIELD_STRUCT_DESC: 24-inch corrugated metal gravity drainage pipe through the levee, 12 feet below the crown. Flap gate on the waterside (WS) end. Concrete headwall on each end. Installed by USACE in 1961. [Additional Reference(s): DWR Levee Log, 1992. USACE San Joaquin O&M Manual 6, September 1961, (HLM 2.65)]. FS Date: 11/5/2013

LS view: concrete headwall with CMP 70 ft off the levee center.

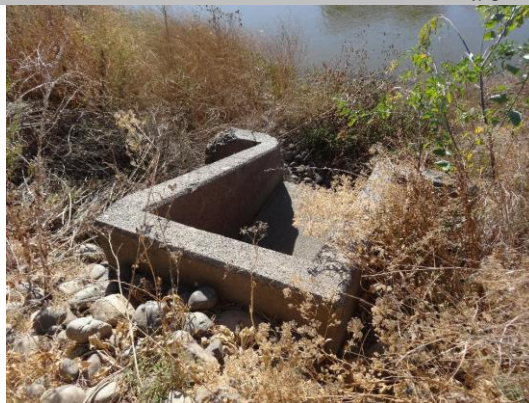
Photo 1 of 3 : UCIP_SP_2018_25023_45102.jpg

LM Start	2.68	Rating **	A/W	Issue No.	68
LM End	2.68	Issue Type +	Ma	Location *	
Category	Supplemental			GPS Latitude/Longitude	
				Start	End
Item	DWR UCIP LMA Responsibility			37.447475 °	37.447475 °
				-121.026017 °	-121.026017 °
DWR ID					
Comment Code					
Inspector Comment					
FS_ID:25023					
DS_ID:22087					
EP_NO: N/A					
Repair Type: No Action Needed					
Crossing Status: Found					
UCIP Comments: Both pipe ends about 85 feet off the levee center.					
FIELD_STRUCT_DESC: 24-inch corrugated metal gravity drainage pipe					
through the levee, 20.3 feet below the crown. Flap gate on the					
waterside (WS) end. Concrete headwall on each end. Installed by					
USACE in 1961. [Additional Reference(s): DWR Levee Log, 1992.					
USACE San Joaquin O&M Manual 6, September 1961, (HLM 2.71)].					
FS Date: 11/5/2013

WS view: U typed concrete headwall on river bank.

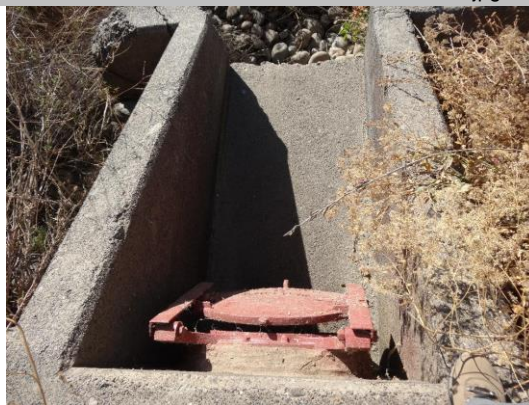
Photo 2 of 3 : UCIP_SP_2018_25023_45101.jpg

WS view: pipe, flap gate, and concrete headwall on river bank.

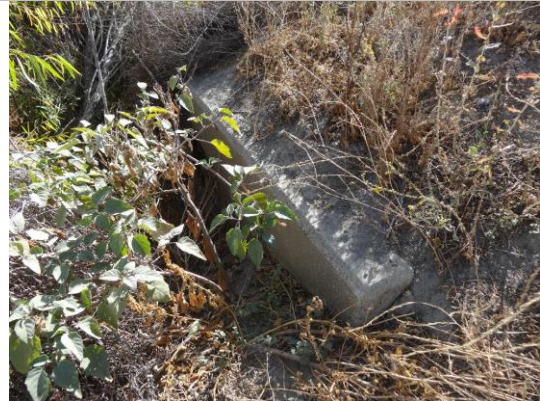
Photo 3 of 3 : UCIP_SP_2018_25023_45100.jpg

LS view: pipe and concrete headwall off the levee toe.

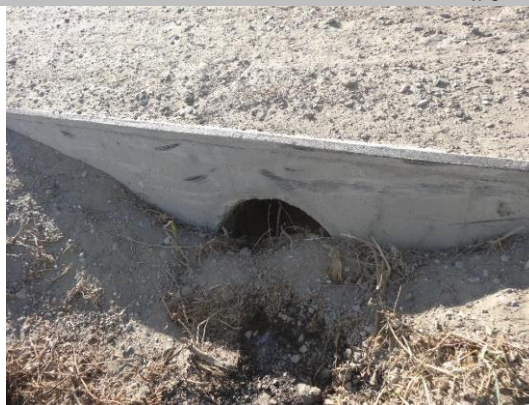
Photo 3 of 3 : UCIP_SP_2018_24443_43520.jpg

WS view: pipe, flap concrete headwall with soil debris blocking the inlet.

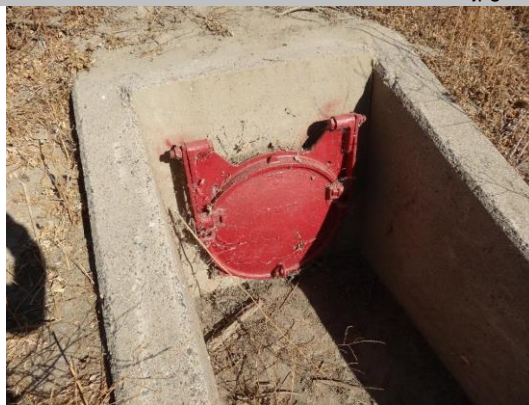
Photo 2 of 3 : UCIP_SP_2018_24469_43644.jpg

WS view: new flap gate, and U typed concrete headwall.

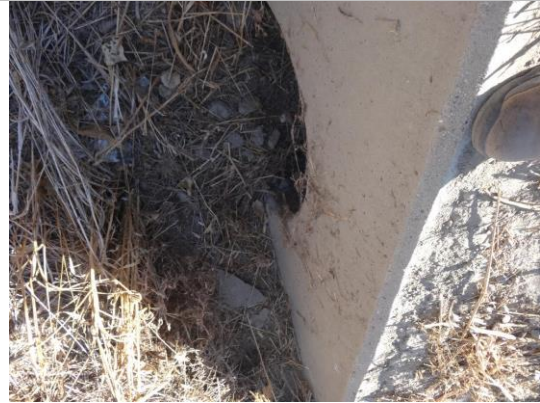
Photo 3 of 3 : UCIP_SP_2018_24469_43643.jpg

LS view: CM pipe and concrete headwall on levee slope. Debris blocking inlet pipe.

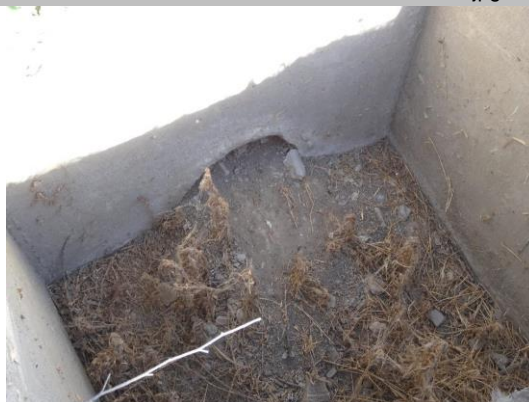
Photo 3 of 3 : UCIP_SP_2018_24485_43665.jpg

LS view: inside view of inlet box on levee toe. Debris blocking inlet pipe.

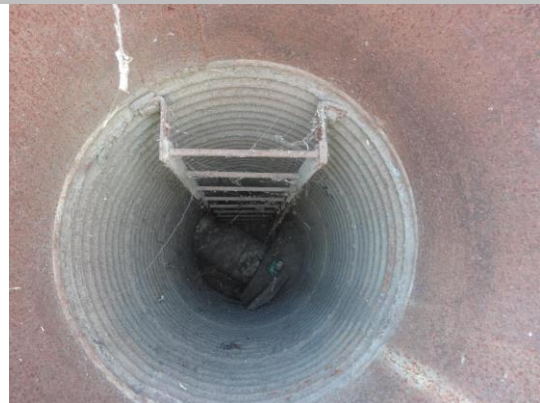
Photo 2 of 3 : UCIP_SP_2018_41746_43849.jpg

WS view: inside view of CMP riser on levee slope. Steel pipe and 24" CMP visible inside the riser.

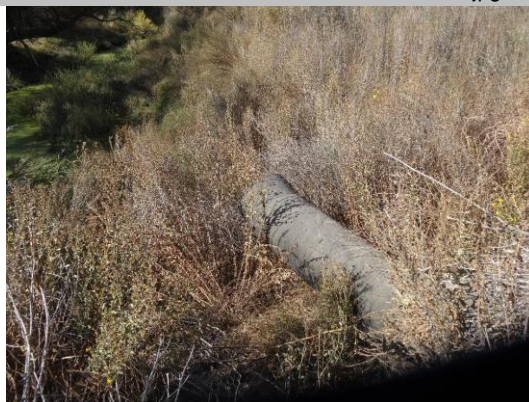
Photo 2 of 3 : UCIP_SP_2018_25025_45109.jpg

WS view: discharge pipe end on levee toe. No flap gate.

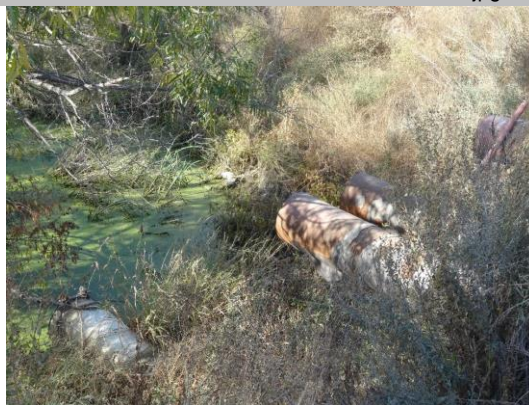
Photo 2 of 3 : UCIP_SP_2018_25026_45114.jpg

WS view: discharge pipes end on levee toe. No flap gates on right 3 pipes.

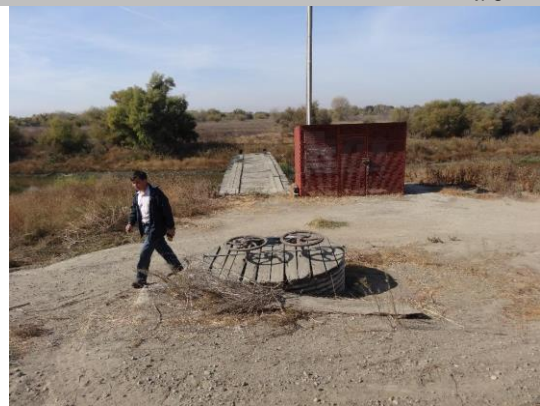
Photo 1 of 3 : UCIP_SP_2018_41669_45131.jpg

WS view: CMP riser, abandoned walkway, power pole on levee slope.

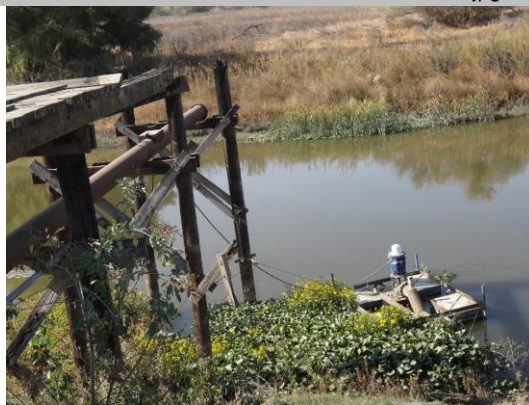
Photo 3 of 3 : UCIP_SP_2018_41669_45129.jpg

WS view: abandoned walkway, pipe (left) and pump on floating structure in the river.

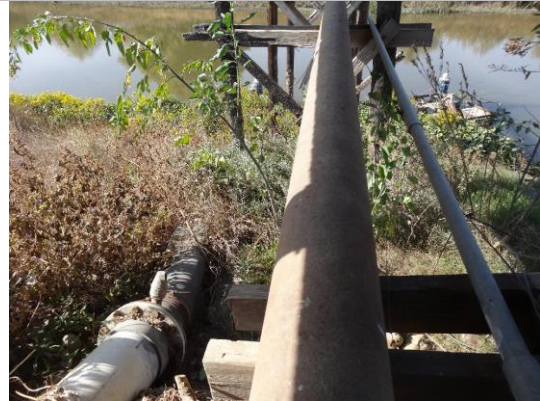
Photo 3 of 3 : UCIP_SP_2018_41670_43903.jpg

WS view: abandoned steel pipe (right), rubber pipe attached to steel pipe to pump on floating structure in the river.

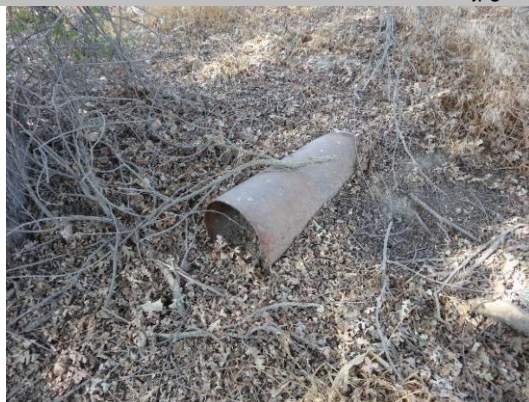
Photo 2 of 3 : UCIP_SP_2018_25031_45140.jpg

WS view: steel pipe with open-end on waterside slope.

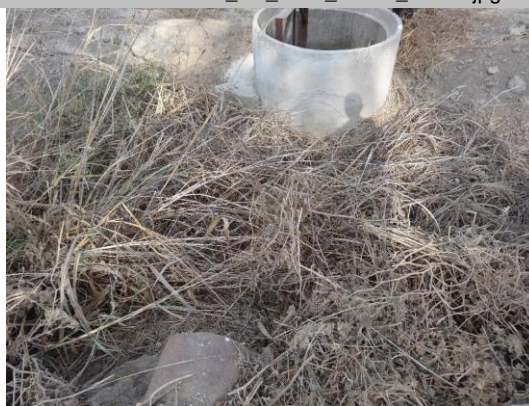
Photo 3 of 3 : UCIP_SP_2018_25031_45139.jpg

LS view: open-ended steel pipe on levee slope (bottom).

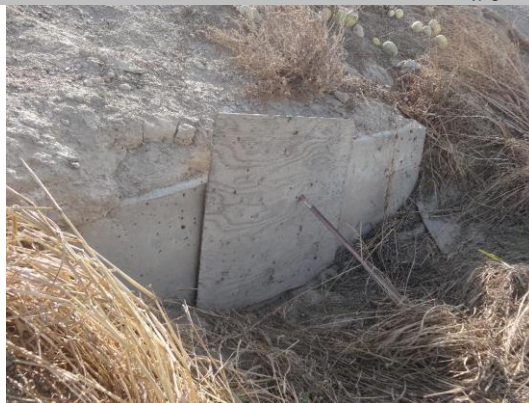
Photo 3 of 3 : UCIP_SP_2018_51825_43982.jpg

LS view: concrete headwall on levee end. Pipe opening blocked by plywood.

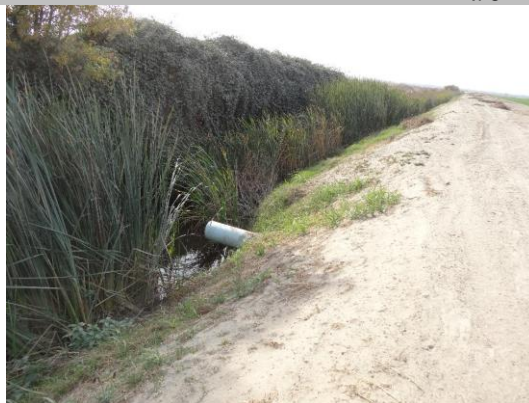
Photo 1 of 3 : UCIP_SP_2018_52539_43990.jpg

WS view: PVC pipe with open end on levee slope.

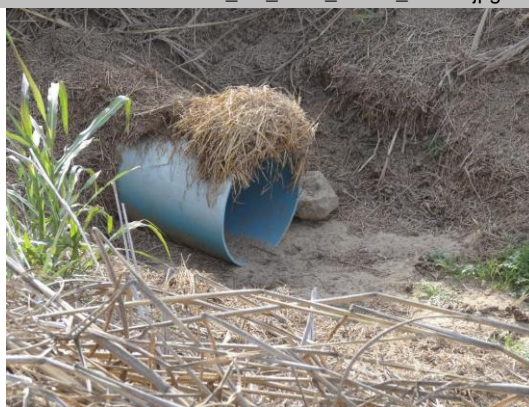
Photo 2 of 3 : UCIP_SP_2018_52539_43989.jpg

LS view: PVC pipe with open end on levee toe.

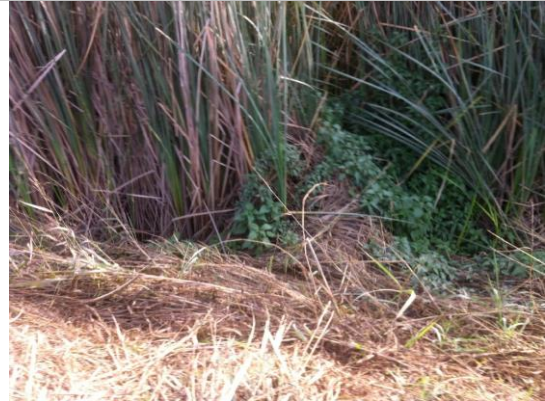
Photo 3 of 3 : UCIP_SP_2018_52540_43991.jpg

WS view: dense vegetation, no pipe visible.
